**MASSACHUSETTS COASTAL BASIN
GLOUCESTER, MASSACHUSETTS**

**UPPER BANJO POND DAM
MA 00185**

**PHASE I INSPECTION REPORT
NATIONAL DAM INSPECTION PROGRAM**

SEPTEMBER 1979

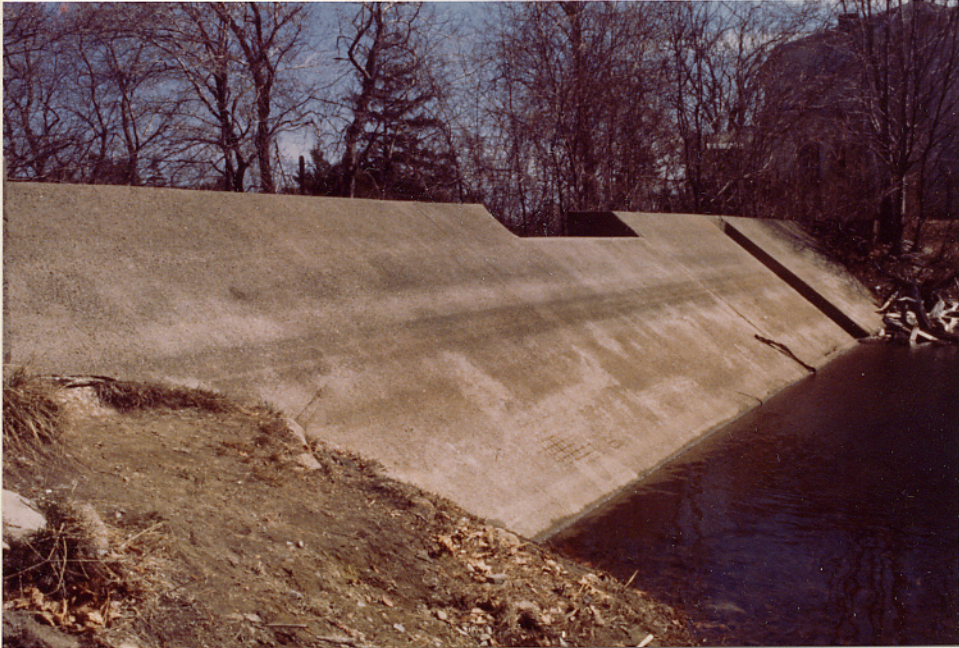
The earth embankments on either side of the concrete buttress dam section are in fair condition. As shown in Photographs No. 1 and 2, there is no riprap protecting the upstream

face where it abuts the sloping concrete slab of the dam. Elsewhere along the embankment, the riprap cover is relatively continuous. The cap wall on the crest of each embankment shows heavy spalling and chipping of the concrete.

NO. 1 UPSTREAM FACE OF DAM FROM LEFT EMBANKMENT

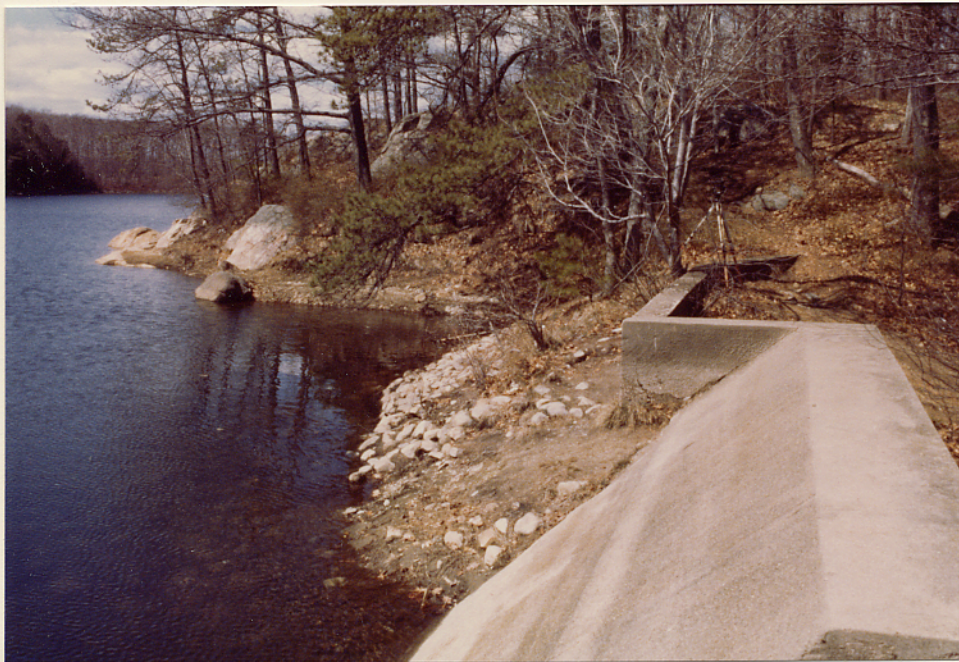
NO. 2 UPSTREAM FACE OF DAM AND LEFT EMBANKMENT

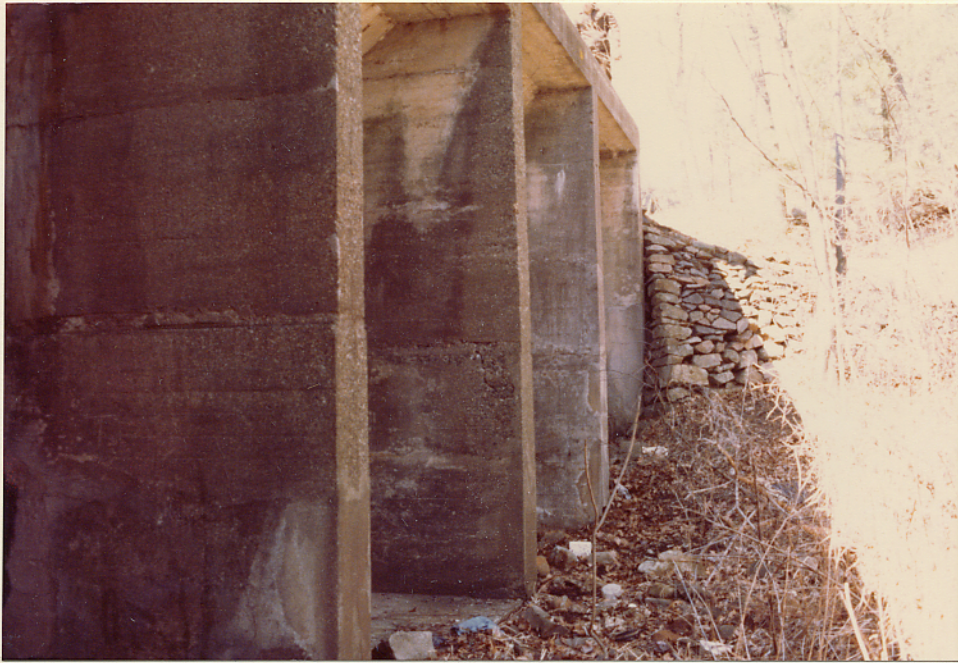
**NO. 3 DOWNSTREAM FACE OF DAM, BAYS
4 THROUGH 7 AND LEFT EMBANKMENT**

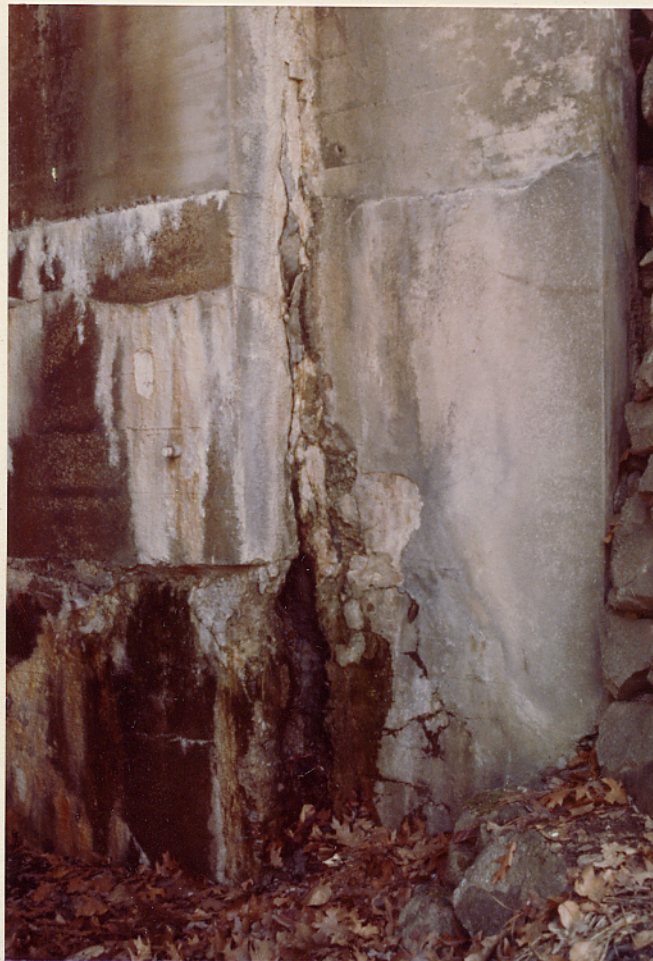
NO. 4 SPALLING IN LEFT WALL OF BAY NO. 7

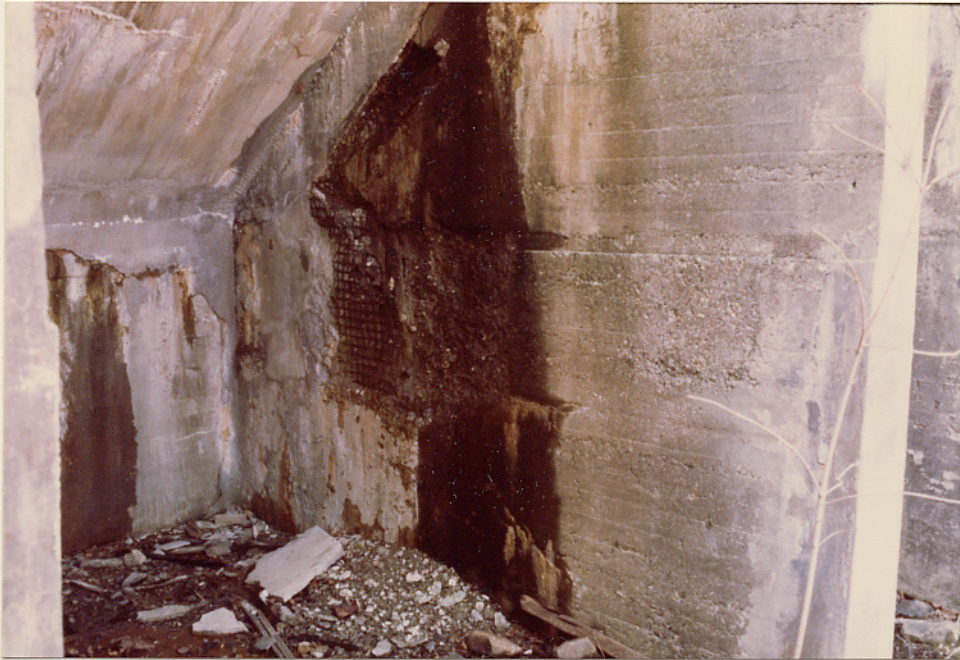
Much of the rubble from the spalling concrete has accumulated at the foot of the buttress. Also, the gunite repair work performed in 1954 shows numerous hairline fractures throughout. The gunite has fallen away in one of the seepage areas, exposing the wire fabric that was added to the wall before the gunite was applied. Not visible in Photograph No. 5 is the accumulation of orange-stained water in the floor of the bay.

NO. 5 SPALLING AND SEEPAGE IN BAY NO. 2

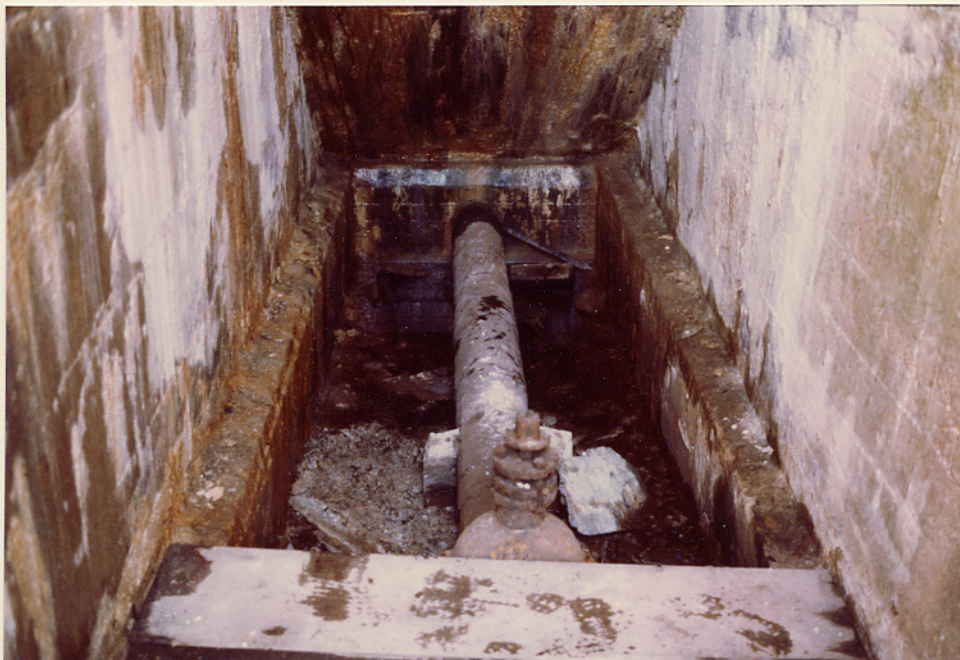
Photograph No. 6 shows the poor condition of the concrete in Bay No. 3, which is also the gate chamber. Heavy efflorescence and staining, as a result of seepage through the concrete, is visible in both buttresses and in the upstream, vertical wall. In addition, there is water dripping from the ceiling of the chamber where the concrete is heavily spalled and crumbling. Some steel reinforcing is visible in the spalled areas.

There is a large crack in the upper part of the right buttress (not shown in the photograph) of Bay No. 3 that extends vertically through the concrete deck of the dam, to the recessed inlet in the upstream face of the dam.

As seen in Photograph No. 6 and discussed previously in Section 3.1.b., the gate chamber in the dam is in poor condition. At the time of the inspection, the pipe was visible above the floor of the chamber. However, the Owner's representative stated that the pipe is usually covered with water. The source of the water may be either the seepage through the concrete or a leak in the pipe or gate valve.

**NO. 6 OUTLET PIPE AND GATE VALVE
STEM IN GATE CHAMBER (BAY NO. 3)**

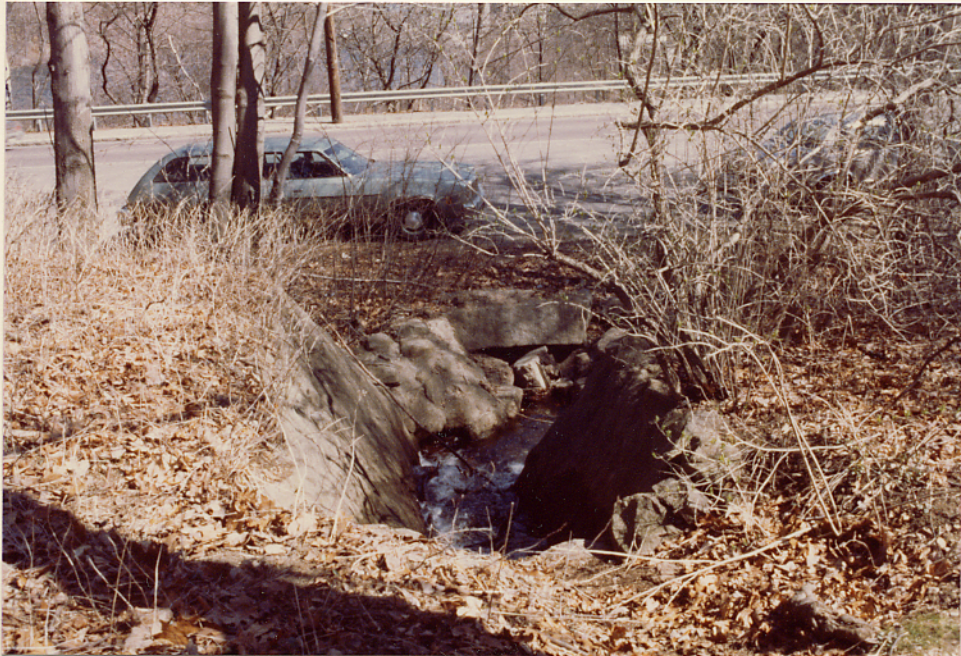
- e. Downstream Channel. The discharge channel below the outlet has a stone-paved floor and rubble stone side walls covered with a thick coat of gunite. The channel is in fair condition, although there are several small trees growing on its banks and overhanging the sides. Minor erosion of the ground surface has occurred just upstream of the outlet.

**NO. 7 CONCRETE AND STONE CHANNEL BETWEEN
OUTLET PIPE AND CULVERT UNDER ESSEX AVENUE**

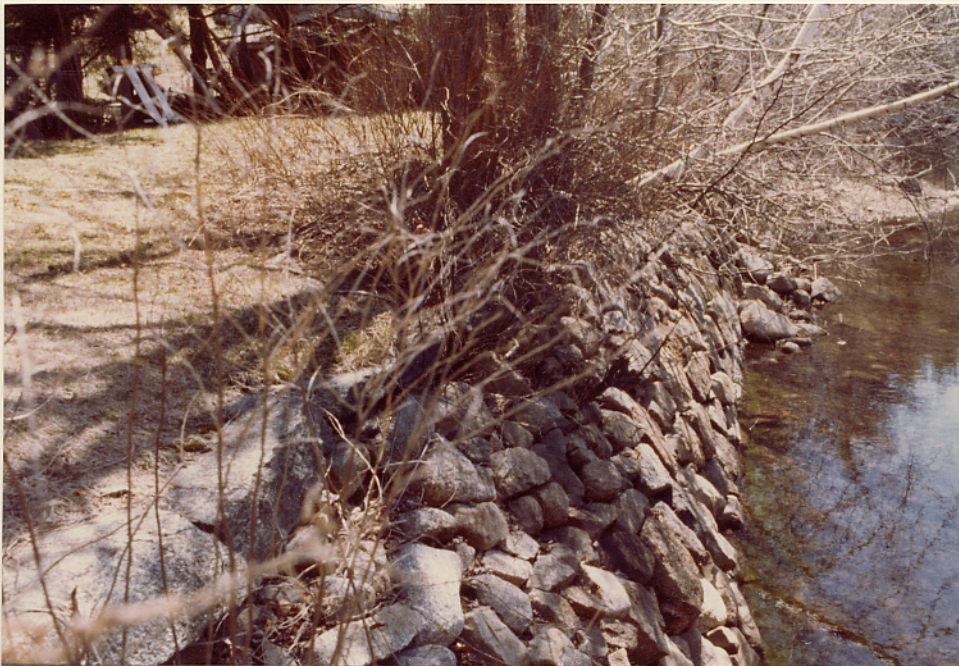
The embankment of the dike is in fair condition. The northern half of the upstream slope is covered with hand-placed riprap. At the southern end of the riprap, however, there is a slight bulge in the slope and the rock has slumped into the pond (see Photograph 8). There are several trees growing at the top of the slope, but there are no trees on the crest of the dike. The crest and downstream slope are covered with grass. No seepage was visible at the toe, however the water level in the reservoir was below the elevation of the toe of the slope.

NO. 8 VIEW OF DIKE FROM LEFT ABUTMENT
